# END-OF-FIELDWORK MANAGEMENT SUMMARY

## *Archaeological Resources Studies at Various Locations Adjacent to or in CUs 79 through 84 in River Section 3, Hudson River PCBs Superfund Site*

**General Electric Company**  
Albany, New York

**URS Corporation**  
Burlington, New Jersey

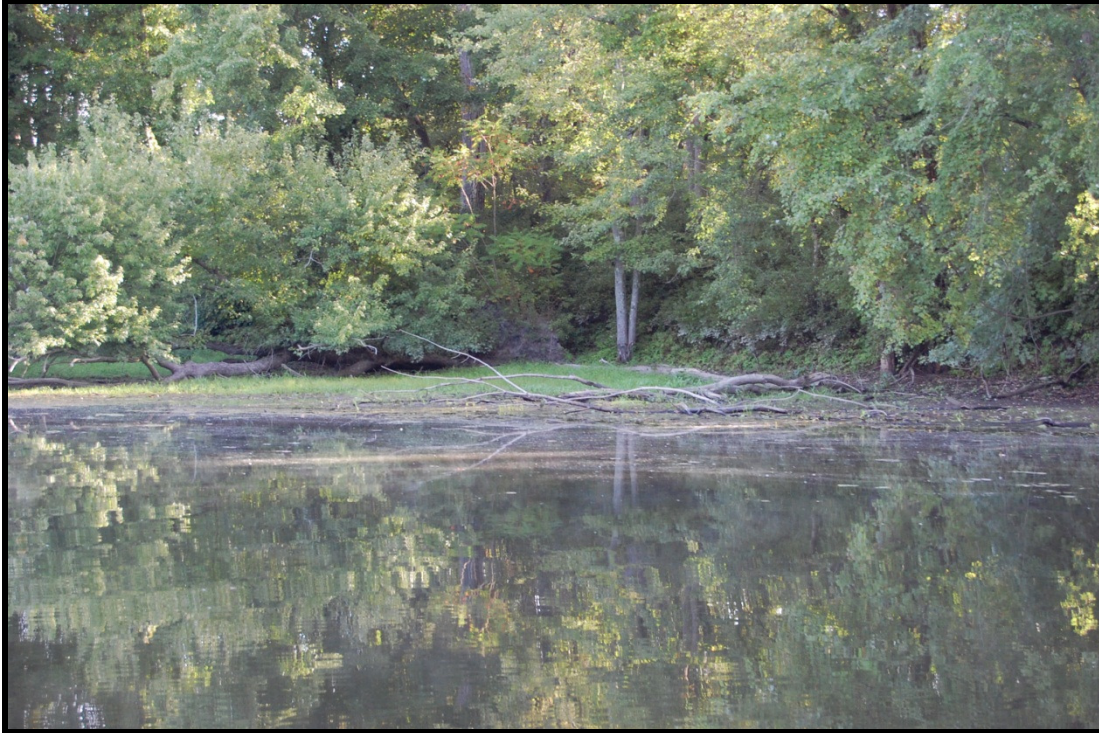
The western shoreline of an unnamed island that abuts a portion of CU 80 was visually inspected from a boat and via a surface inspection on foot on September 9, 2013. The western shoreline of the island exhibits a low T1 terrace several meters away from the CU, with a lower T0 mudflat between it and the edge of CU 80 (**Figure 1**). No features or artifacts were observed, and this inspection confirmed the previous assessment that the terrain abutting the edge of the CU is relatively low and poorly drained and should not be considered to have archaeological high sensitivity. Based on this reconnaissance, we conclude that dredging activities in CU 80 adjacent to this island will have no adverse impacts on potentially significant archaeological deposits because there are no such deposits adjacent to the CU. We therefore recommend that no additional archaeological studies be required for the portion of CU 80 that abuts this unnamed island.

**Figure 1. Photograph of Western Shoreline of Unnamed Island, View East Showing Low T0 Terrace (at edge of waterline).**

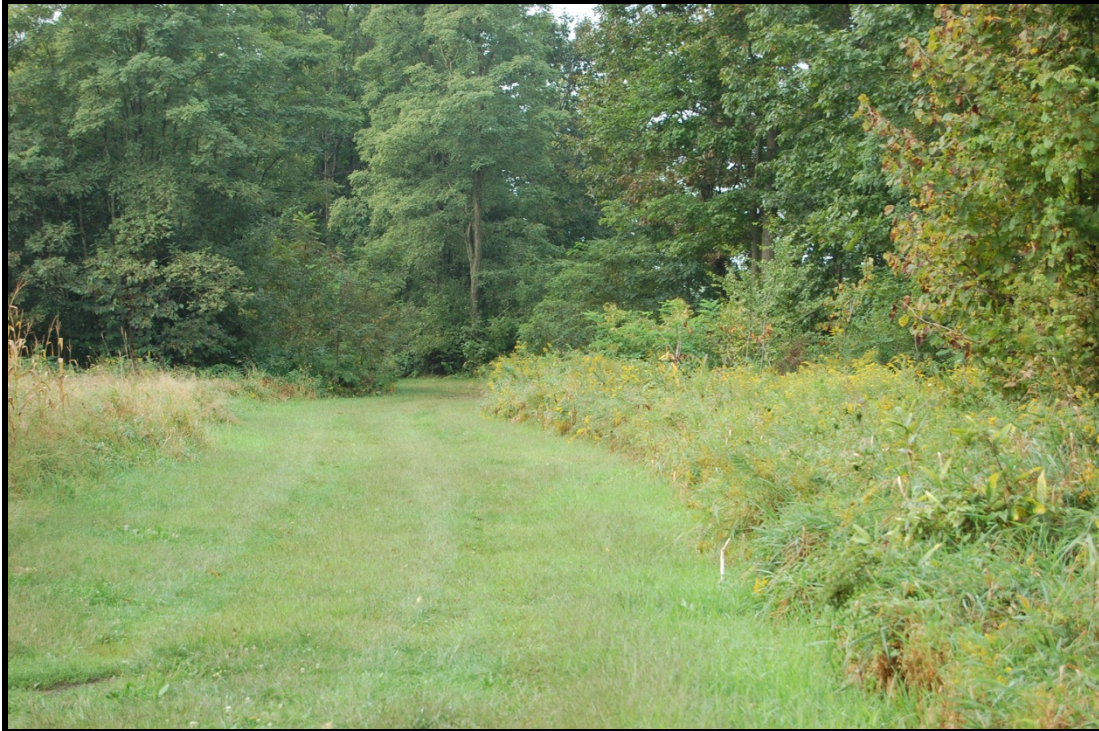
Area CSD-a is a wooded field edge on the east bank of the Hudson River. The northern third is situated on a high T1 terrace approximately 1.0 to 1.5 meters above the Hudson River (**Figure 2**); the southern two-thirds is situated on a low T0 terrace consisting of recent alluvium and gravel deposits (**Figure 3**). Area CSD-a was subjected to shovel testing on September 12, 2013. Proceeding north-to-south, the first four shovel test pits (STPs) were excavated along a transect at 15-meter intervals in the northern third of the area. No cultural materials were recovered from these STPs. South of STP A-04 (the southernmost of these STP), the survey transect dropped down to the T0 terrace. Two judgmental shovel tests were conducted in this area, revealing a thin (approximately 10 centimeter thick) layer of recent alluvium overlying gravel deposits and no cultural materials. In addition, the entire southern two-thirds of area CSD-a was visually inspected, but no STPs were excavated aside from the two judgmental shovel tests. This visual inspection did not exhibit any evidence of the potential presence of cultural materials.

**Figure 2. Photograph of T1 Terrace in Area CSD-a, View South (Hudson River to right).**

In summary, the shovel tests and visual inspection of area CSD-a did not produce cultural materials and did not exhibit any evidence of archaeologically sensitive soils or deposits. As a result, we recommend that no further work be required in Area CSD-a prior to dredging activities in CU 83.

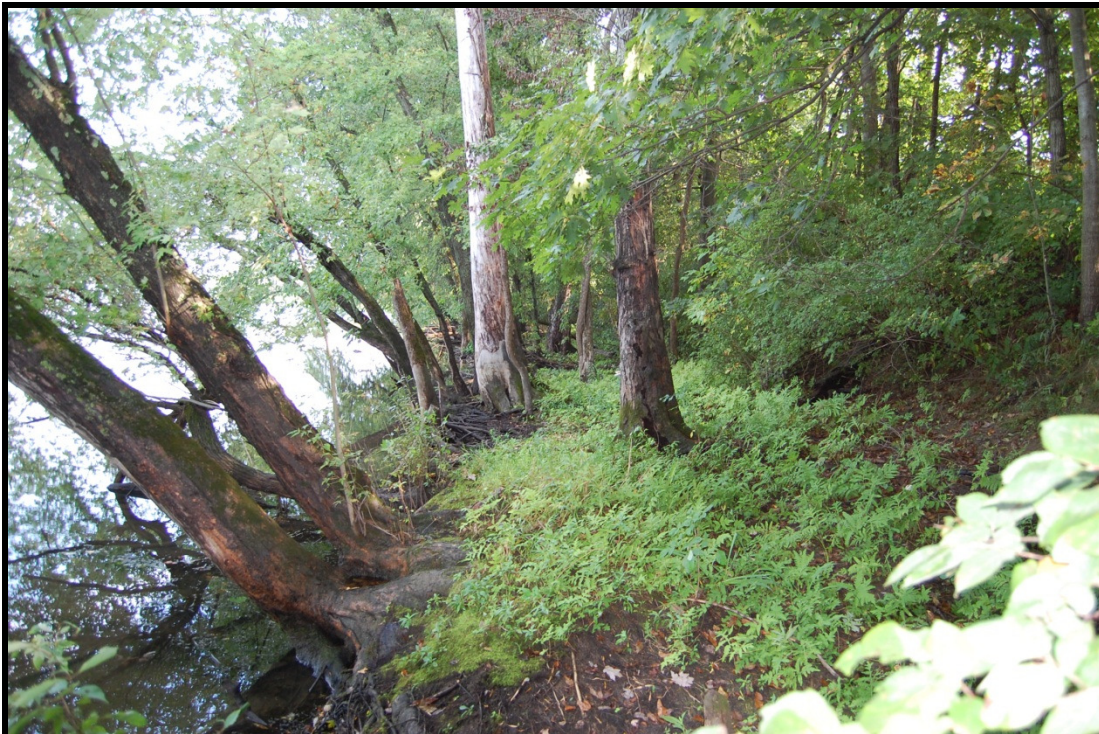
**Figure 3. Photograph of Low T0 Terrace in Area CSD-a, View North.**

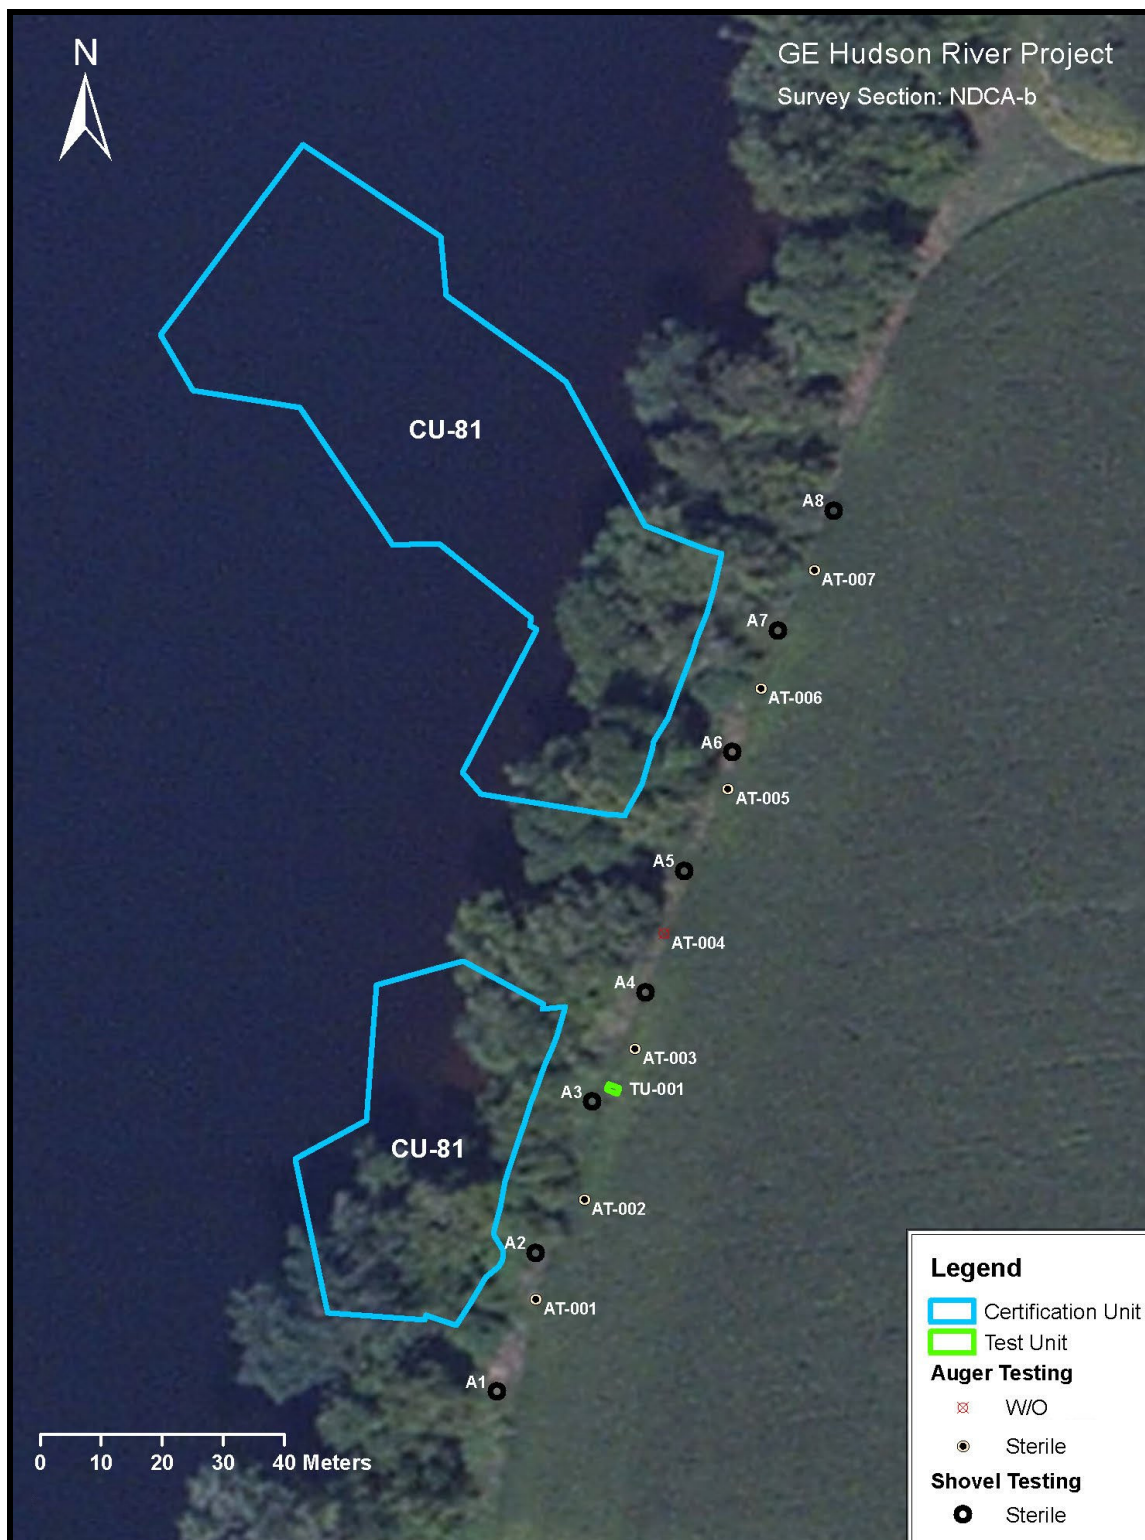
As discussed in the Terrestrial Fieldwork Summary Report (URS 2013a), URS performed a Phase I survey and shovel testing in July 2013 in the archaeological area designated as NDCA-b, which is adjacent to two sections of CU 81 on the eastern side of the Hudson River (**Figure 4**). During this investigation, eight STPs were excavated at 15-meter intervals adjacent to the two portions of CU 81. The shovel testing began just south of the southern edge of the southern dredge area and proceeded northward to just north of the northern edge of the northern dredge area. None of these STPs produced cultural materials. However, soils encountered in the approximately one-meter deep STPs consisted of well-drained sandy soils with an upper A-horizon approximately 60 to almost 90 centimeters deep overlying a B-horizon; and it was noted that the shovel-tested landform is approximately 1.5 to 2 meters above the Hudson River water level. Given these conditions, URS concluded that it was unlikely that the shovel tests penetrated deep enough for a clear understanding of the presence/absence of cultural materials in deeply buried contexts. As a result, in *Addendum No. 1 to Terrestrial Archaeological Resources Survey Work Plan for Phase 2 Dredge Areas Below Northumberland Dam (River Section 3)* (URS 2013c), submitted on September 4, 2013, URS recommended that deep subsurface testing be conducted in area NDCA-b to adequately determine the presence or absence of cultural materials and archaeologically sensitive soil layers deeper than one meter.

**Shovel Test Pits.** As discussed in the above-referenced submittals (URS 2013a, 2013c), the eight STPs excavated at area NDCA-b during the July 2013 Phase I survey were all sterile of cultural materials. Soils encountered included an Ap-horizon of dark brown (10YR 3/3) to very dark grayish brown (10YR 3/2) sandy loam overlying a B-horizon of brown (10YR 4/3 or 5/3) to grayish brown (10YR 5/2) loamy sand. The A-horizon was a minimum of 31 centimeters thick to a maximum of 88 centimeters thick. Half (n=4) of the STPs exhibited an A-horizon 50 centimeters thick or thicker, and three-fourths (n=6) exhibited an A-horizon that was 40 centimeters thick or thicker. In all STPs, the B-horizon extended to the base of units (typically 80-100 centimeters overall depth).

Figure 4. Map of URS' 2013 Phase I Results in Survey Area NDCA-a2.

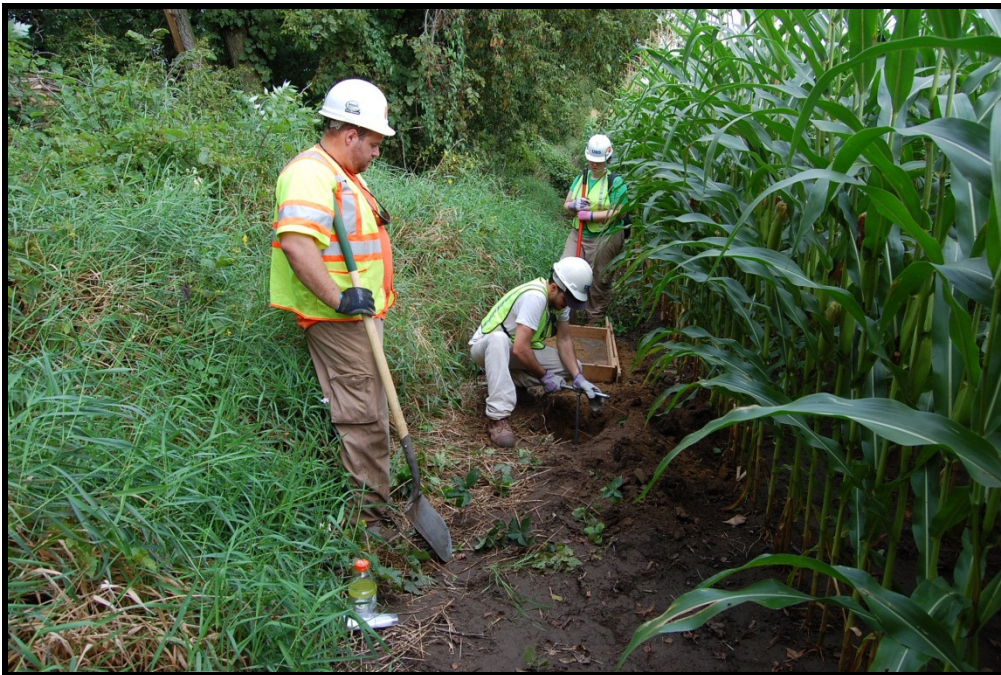
**Auger Tests.** Six ATs were excavated at area NDCA-b. These were placed roughly between the initial STPs. Specifically, the ATs were spaced 15 meters apart, but were placed 7.5 meters from the previous STPs. The auger used was a four-inch-diameter bucket auger that allowed for excavation to 190 centimeters in depth (**Figure 5**). No artifacts were recovered from any of the ATs. All six ATs encountered the same soil package, consisting of four strata. The first two strata were the same as described above for STPs. ATs documented that Stratum II extended to depths of 85 to 120 centimeters below the ground surface. Underlying this was a B2-horizon of yellowish brown (10YR 5/6) silty sand (Stratum III) and a B3-horizon of yellowish brown (10YR 5/4) silty sand (Stratum IV). Stratum III ended between 125 and 168 centimeters below the ground surface; Stratum IV extended to the base of all ATs.

**Figure 5. View of Auger Testing at NDCA-b, View North.**

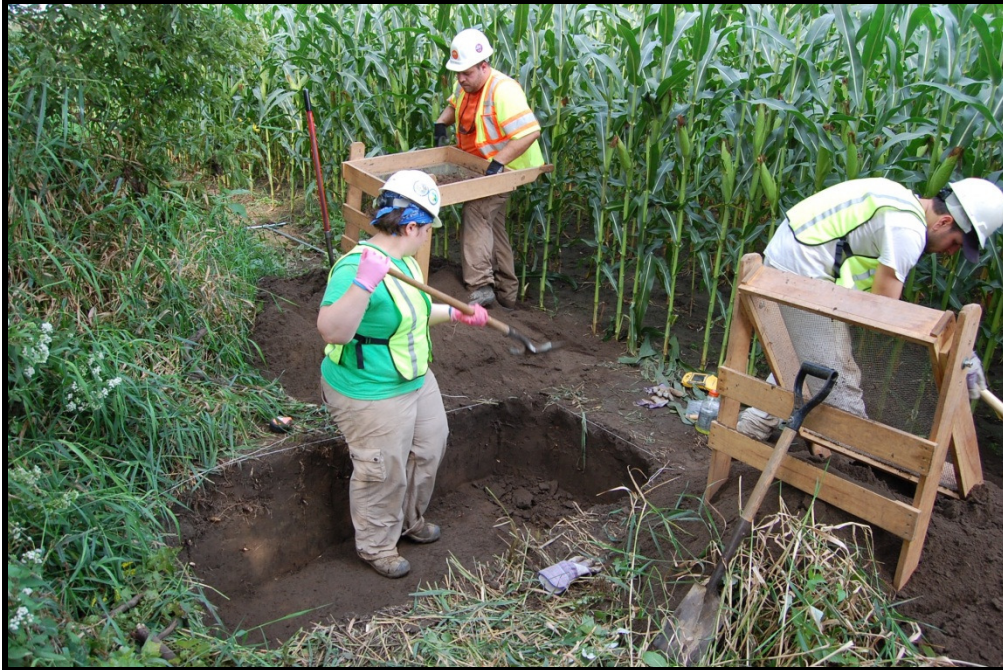
**Test Unit.** A single TU measuring one meter (north-south) by two meters (east-west) was excavated to gain a better understanding of the soils as well as to provide a larger sample for the potential recovery of artifacts (**Figure 6**). The TU was excavated in arbitrary 10-centimeter levels within natural strata. The whole TU was excavated to a depth of 90 centimeters, and the eastern half was excavated further to a depth of 132 centimeters. An AT was placed in the base of this TU to reach an overall depth of 305 centimeters below the ground surface. The TU encountered the same four strata described for ATs above (**Figure 7**). The AT in the TU encountered the same fourth stratum (B3-horizon) to its base at 305 centimeters. Groundwater was encountered in the AT at 275 centimeters, and the B3-horizon below that depth exhibited mineral staining typical of near-constantly saturated conditions (e.g., iron and manganese stains).

The TU produced five artifacts. These were all recovered from a small horizontal and vertical area in the eastern part of the TU at a depth of approximately 50-55 centimeters in the B1-horizon (Stratum II, excavation level 5). The five artifacts consist of four prehistoric items (three chert flakes and a quartzite

fire-cracked rock fragment) and one historic item (coarse earthenware ceramic sherd). Given the horizontally and vertically limited location of these items, coupled with the mix of prehistoric and historic items, we believe that these items were redeposited from another location, likely the result of bioturbation or flooding.

**Figure 6. View of Test Unit Excavation at NDCA-b, View Northeast.**

Given the lack of culturally sensitive soils, coupled with the lack of archaeological resources, we conclude that dredging activities at CU 81 will have no adverse impact on significant archaeological resources. Accordingly, we recommend that no further archaeological investigations be required prior to dredging of CU 81.

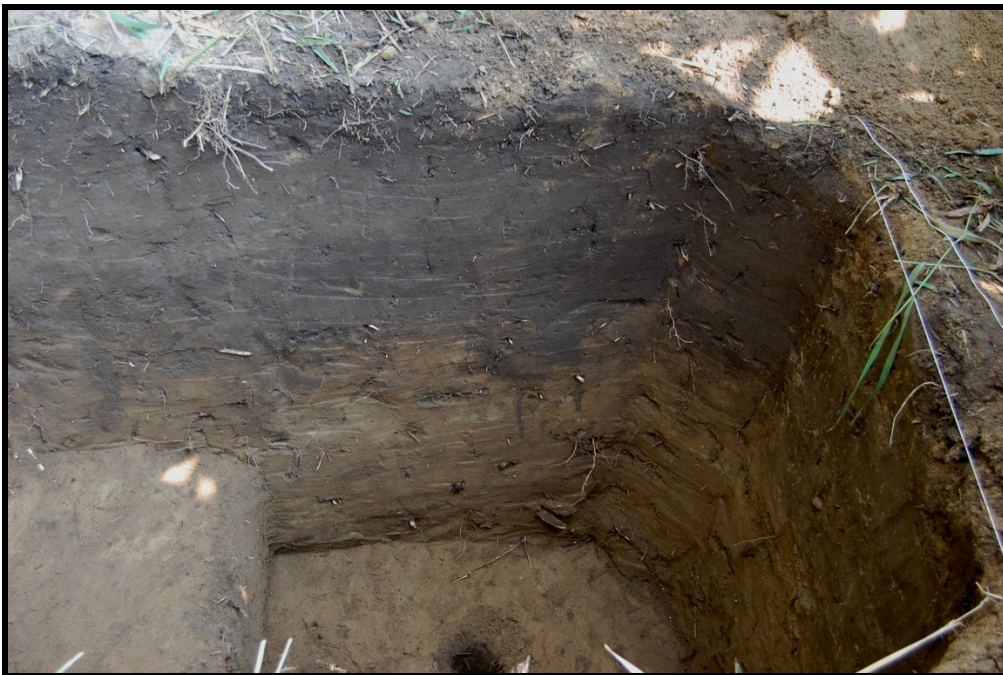
**Figure 7. Photograph of Portion of TU 1 North Profile, View North.**

All excavations at area NDCA-b failed to identify any archaeologically sensitive soils. The soil package in that area consists of a disturbed plowzone overlying a series of culturally sterile B-horizons. All STPs and ATs failed to produce cultural materials. The TU produced five mixed artifacts from a spatially limited area in the B1-horizon. However, the nature of the artifacts and the location from which they were recovered indicate that they are the result of redeposition and do not represent a primary deposit of cultural materials. Therefore, they do not represent an archaeological site.

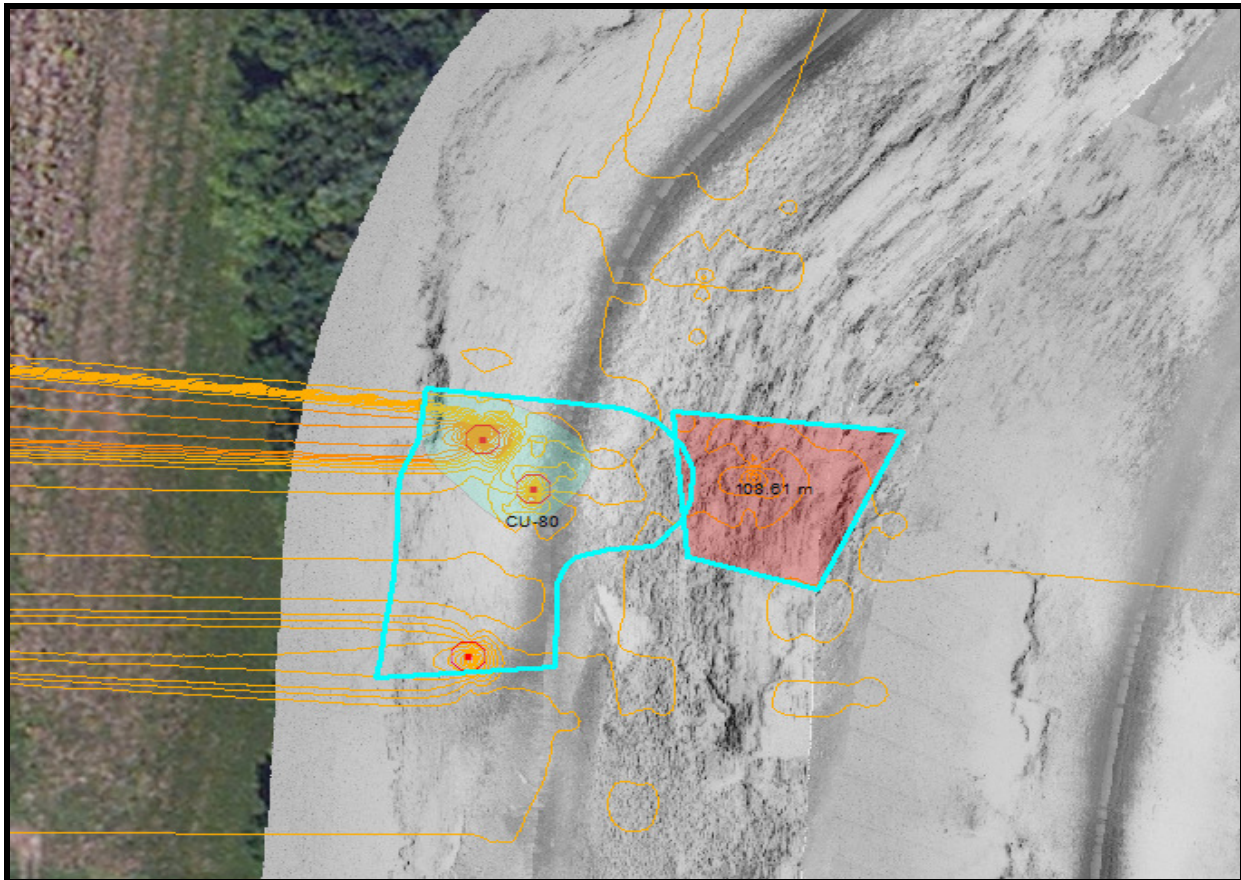
Figure 8. Mooring Area 1 CU 80

Area 1 is located on the western bank of the river on the eastern side of CU 80 (coordinates 738089.021, 1552681.326) and is bordered by agricultural fields (**Figure 8**). No side-scan sonar anomalies were recorded in this area, but there is one small dipole located at the above coordinates. This anomaly does not have complex characteristics typically associated with a significant cultural resource and was not identified for further evaluation.

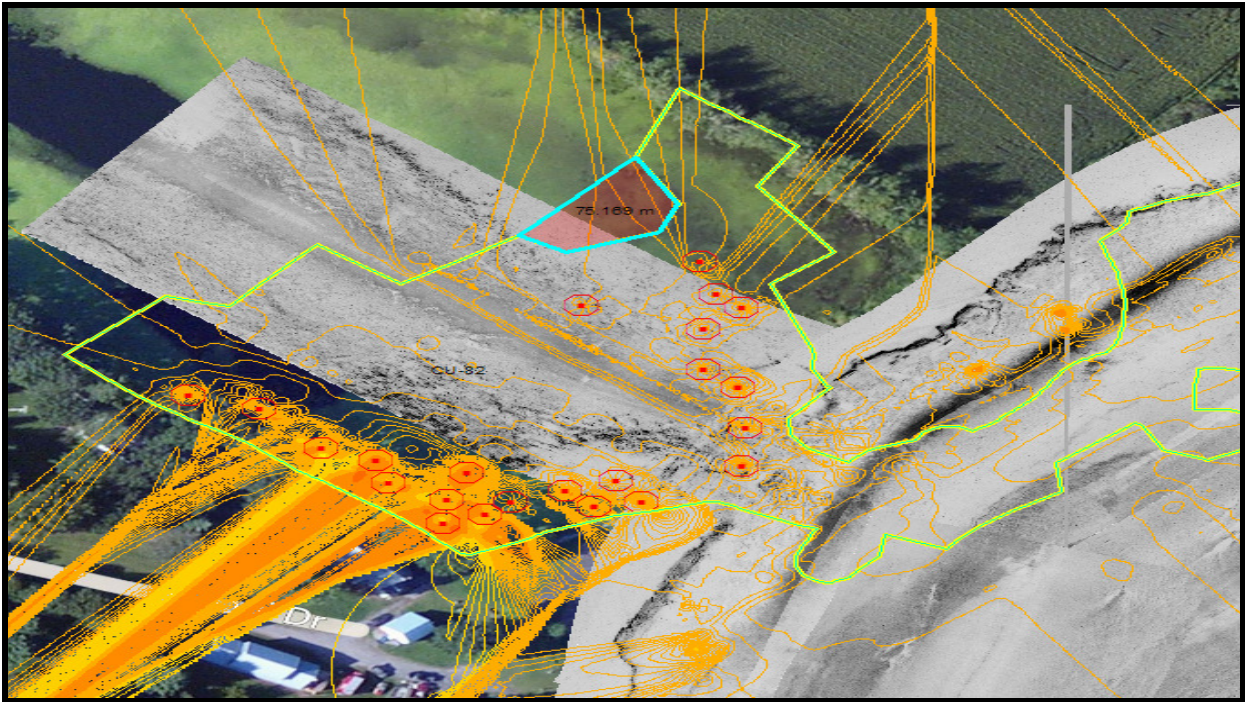
Mooring Area 2 is located on the western bank of the river (**Figure 9**), in a small side channel leading to the Cove Marina in CU 82 (coordinates 736097.359, 1537964.263). The southern side of the channel has considerable disturbance due to modern house construction and land development. The northern side of the channel, where Mooring Area 2 is located, is bordered by agricultural fields. Both sides of the channel have several small magnetic anomalies that are located along the bank and fence lines. These anomalies are outside of Area 2 but are located within CU82's dredge prism. These magnetic anomalies lack the complexity and distribution associated with a significant cultural resource and have magnetic signatures and patterning associated with bankline debris dumping.

**Figure 9. Mooring Area 2, CU 82**

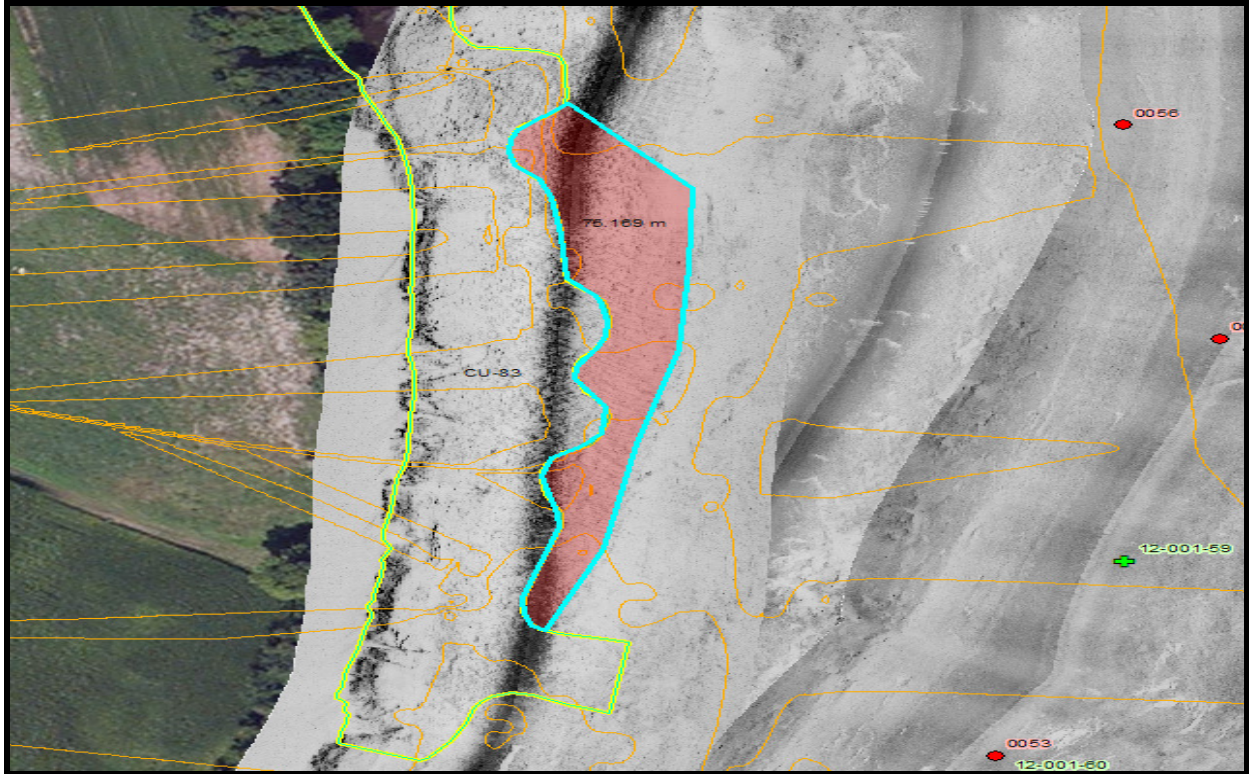
Figure 10. Mooring Area 3 CU 83.

Mooring Area 3 is located along the western bank of the river adjacent to CU 83 (**Figure 10**), and is bordered by agricultural fields (coordinates 738328.262, 1539958.443). No magnetic or acoustic anomalies were recorded in this area. Side-scan sonar data recorded scatters of tree limbs along the river bottom throughout this region.

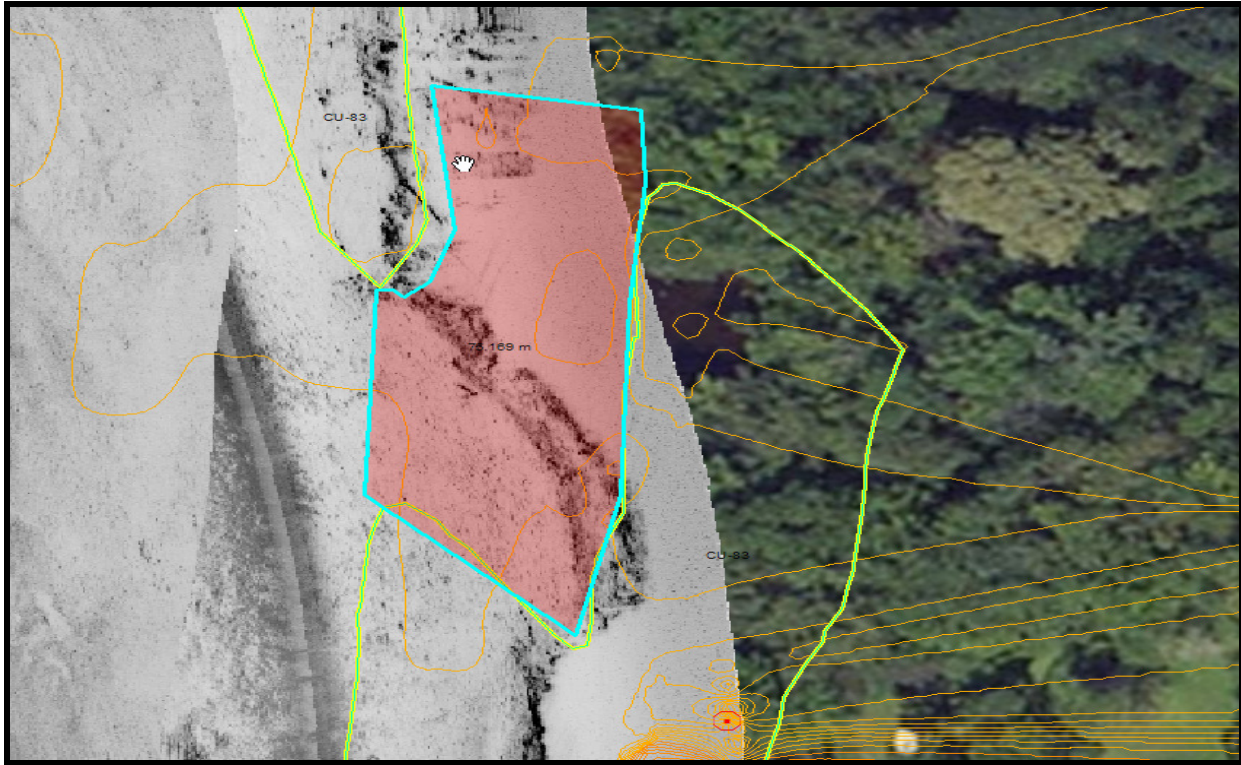
Mooring Area 4 is area is located between two portions of CU 83 along the eastern bank of the river (**Figure 11**), adjoining a heavily wooded area (coordinates 738936.962, 1540453.281). No magnetic or side-scan sonar targets were recorded in this area.

**Figure 11. Mooring Area 4 CU 83.**

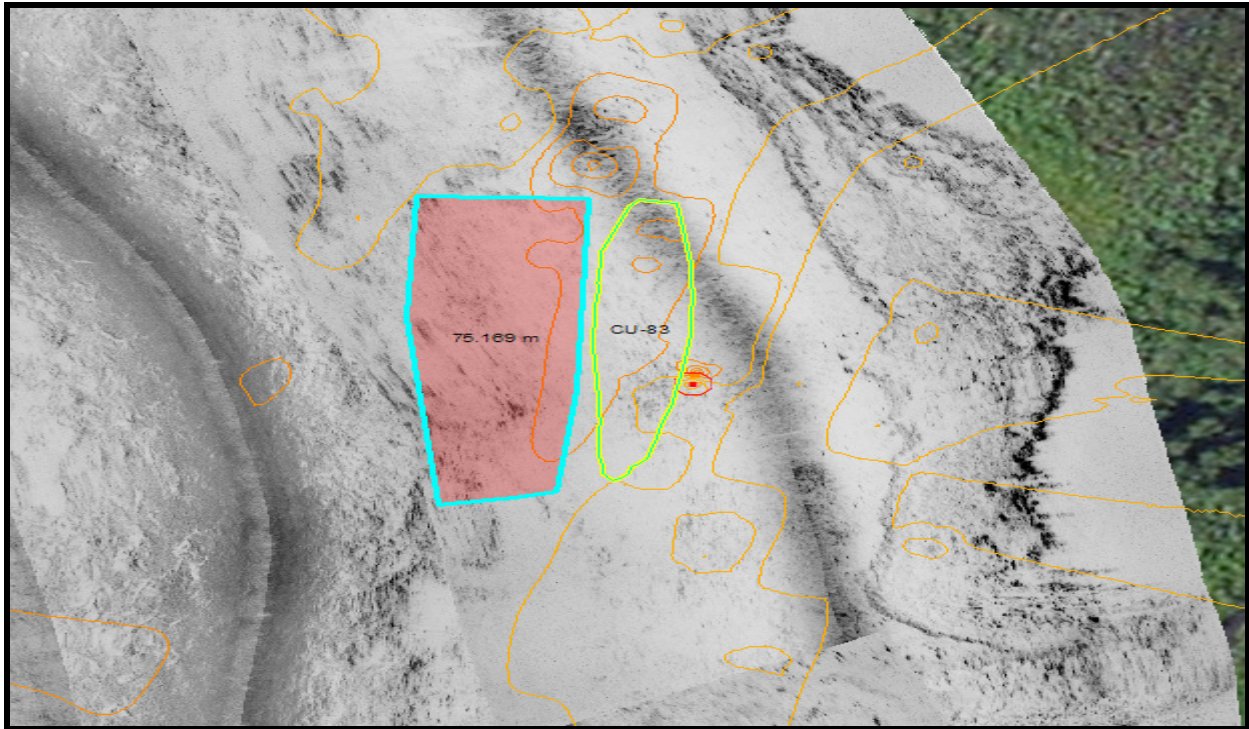
Mooring Area 5 is located on the eastern side of CU 83 along the eastern bank of the river (**Figure 12**), adjacent to a heavily wooded area (coordinates 736660.4221, 1535936.039). No magnetic or side-scan sonar targets were recorded in this area. There are a number of smaller simple dipole anomalies directly to the northeast, but they are outside of this area.

**Figure 12. Mooring Area 5 CU 83.**

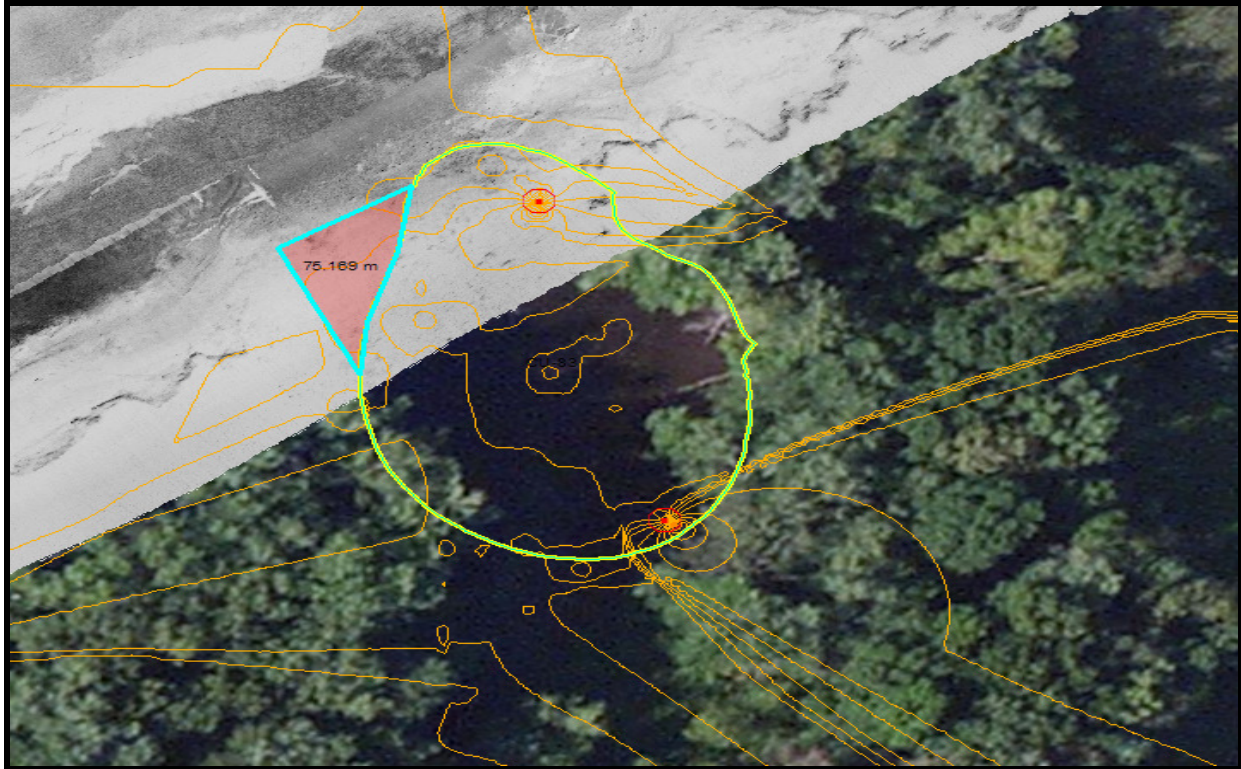
Mooring Area 6 is located on the eastern side of CU 83 along the eastern bank of the river (**Figure 13**), adjacent to a wooded area bordered by agricultural fields (coordinates 739782.316, 1537569.31). No magnetic or side-scan sonar targets were recorded in this mooring area. There are two small simple dipole anomaly directly to the north and east of this area within CU 83.

**Figure 13. Mooring Area 6 CU 83.**
